Property Inspection Report

404 Inspection Way
Dayton, OH 45499

GENERAL INFORMATION

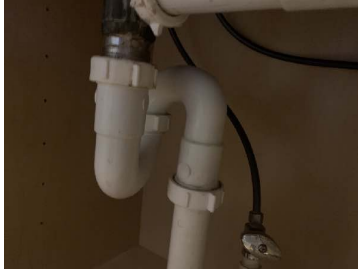
- ☐☐☐☒ **Sink:** Single Bowl >>> Drain plug not operational
S-Trap on drain is not permitted (tendency for sewer gasses to escape, posing a health hazard)

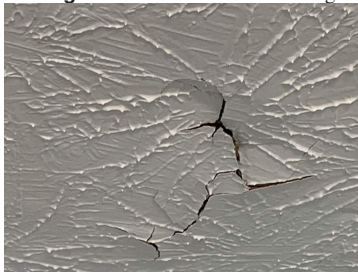
☐☐☐☒☐ **Closet:** (Single Door) >>> Light fixture not operational (detected possible voltage, bulb blown?)
☐☐☐☒☐ **Ceiling:** Textured Finish >>> Damaged area

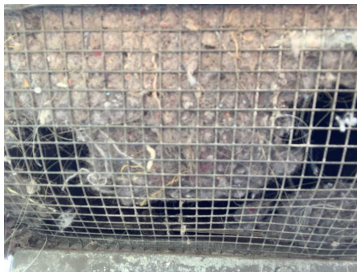
- ☐ ☐ ☐ ☒ **Dryer Vent Termination:** On Roof >>> Screen blocking air flow and lint (bird screen must be removed for dryer use, pipe may require cleaning, fire hazard)

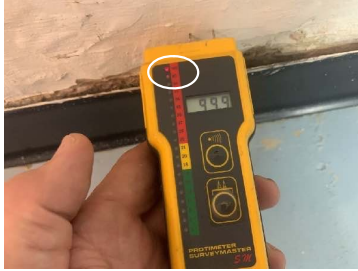
☐☐☐☒ **Walls:** Painted Surface >>> Staining with possible appearance of biological activity (damp, potential health issue, recommend testing for mold to determine a course of action and repair, potential Health Issue)

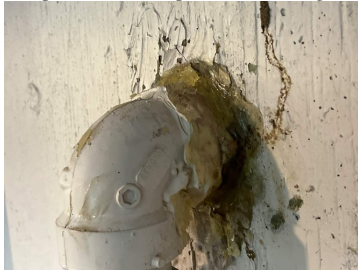
☐☐☐☒ **Sump:** with Submerged Pump >>> Cover missing from sump (safety issue)
Discharge pipe leaking in structure (may cause damage and mold)
Pump float switch is positioned too high for pump to operate correctly

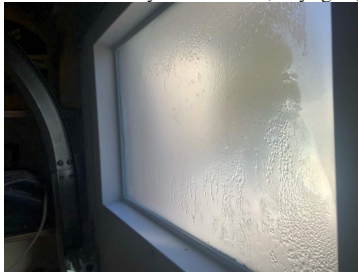
☐☐☐☒ **Windows:** Vinyl Sash/Frame, Skylight (in ceiling) >>> Glass seal failed in sash x1 (moisture and/or fogging between glass in thermo pane unit)

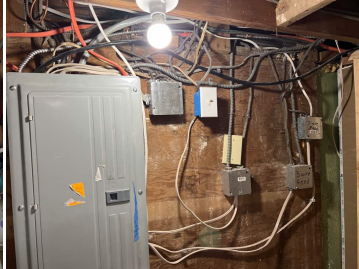
☐☐☐☒ **Electrical:** Components >>> Wiring not secured to structure within 18 inches of junction box as required

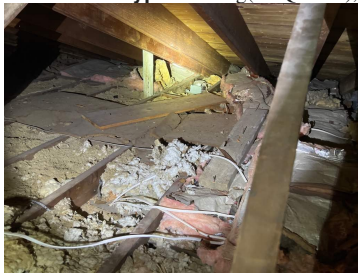
- ☐☐☐☒ **Attic Access:** Ceiling Panel >>> Not insulated (allowing unwanted heat transfer, reducing the overall insulation value)
- ☐☒☐☐ **Unable to Inspect:** Cathedral Ceiling (area) >>> Headroom inadequate to enter safely (hidden problems may exist that are not documented in this report, any comments about interior are observations from that access)
- ☒☐☐☐ **Roof Framing:** Rafters (Stick Framing)
- ☒☐☐☐ **Roof Decking:** Dimensional Lumber (Wood)
- ☒☐☐☐ **Chimney:** Concrete Block
- ☒☐☐☐ **Ventilation:** Located on Ridge & in Soffit
- ☐☐☐☒ **Insulation Type:** Batting(FAQ-Attic), Cellulose Loose Fill(FAQ-Attic) >>> Pulled back from area(s) (allowing unwanted heat transfer from below)

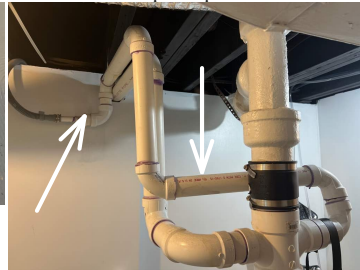
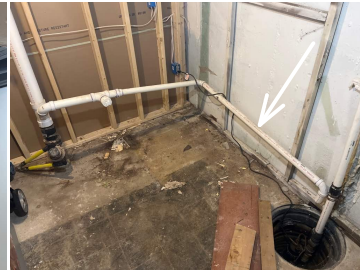
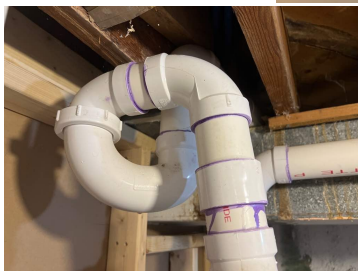
Hall bathroom shower drain appears to be an S-trap: not permitted

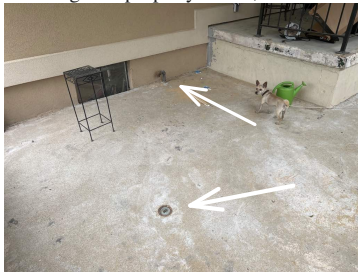
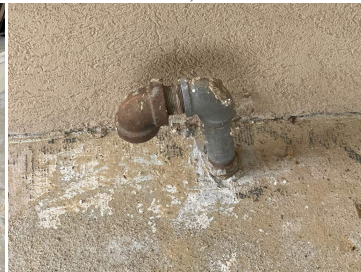
☐☐☐☒ **Fuel Tank:** Underground Abandoned >>> Vent or filler pipe visible outside indicating the possibility of an abandoned underground fuel oil tank (recommend checking with property owner, abandoned tanks must be removed)

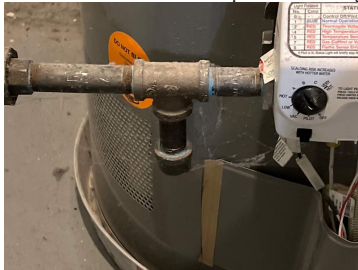
☐☐☐☒ **Gas Lines:** Black Iron Pipe >>> Dirt leg/ Sediment trap incorrectly installed (pipe straight through, cannot perform intended function)

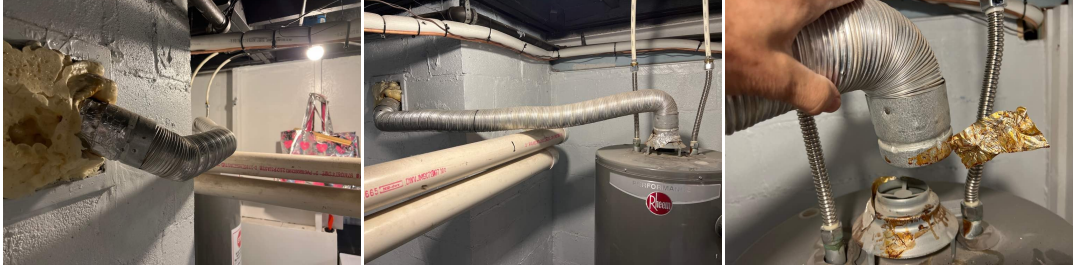
- ☐☐☐☒ **Flue Pipe:** Flex Pipe to Chimney >>> Clearance between pipe and combustibles foam is inadequate (fire safety issue)
Negative downward sloped pipe (requirement is: a constant upward angle of not less than 1/4 inch per ft, carbon monoxide concern)
Pipe not secured to draught hood with screws as required (carbon monoxide concern)

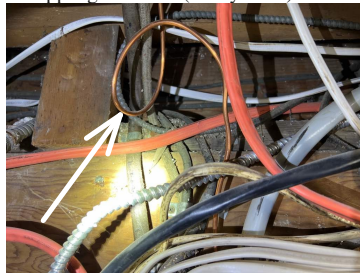
No ground wire/ rod appears to have been installed from the new main exterior disconnect (new or updated electric distribution panel installations require grounding to copper ground rod (safety issue))

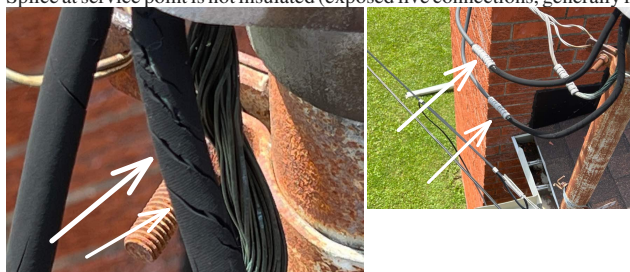
☐☐☐☒ **Incoming Service:** Mast with Overhead Cable >>> Wires outer surface covering deteriorated on service entrance conductor (property owner responsibility)(FAQ-Electrical/Service wire)
Splice at service point is not insulated (exposed live connections, generally responsibility of the utility company, electrocution possible, safety issue)

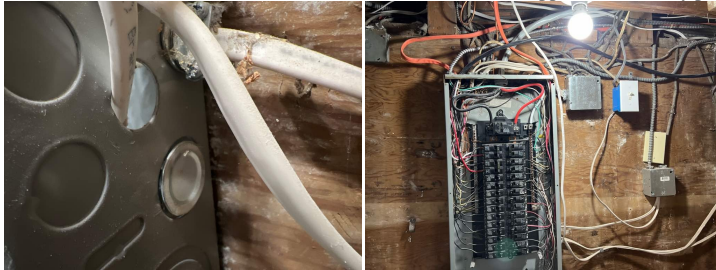
☐☐☐☒☐ **Panel Box:** Seimens (Manufacturer) >>> Wire(s) entering panel box are not clamped (required)
Wiring not secured to structure within 18 inches of panel as required
Insulated covered wires (inside box, wires insulation must be stripped back to entry point)

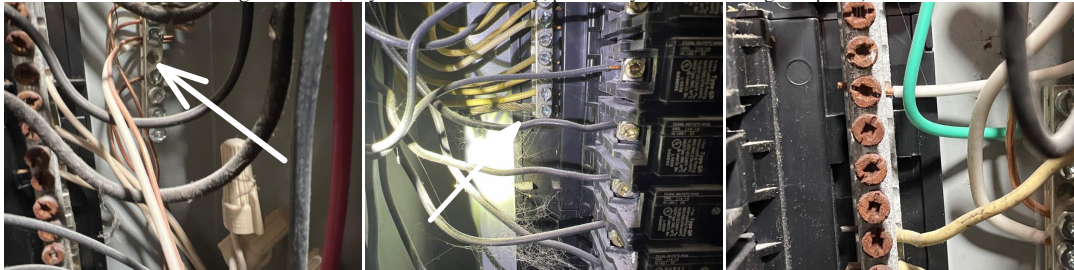
☒☐☐☐☐ **Main Disconnect:** 100 Amps >>> NOTE: Located at meter (making this panel a sub panel for wiring purposes)
☐☐☐☒☐ **Neutral/ Ground Buss:** Separated/ Isolated >>> Neutral wire connected to isolated ground bus bar (error creating a cross connect)
Ground wires touching isolated neutral bus bar (creating a cross connection between separated neutral and ground wiring)
Corrosion or rust on neutral/ground bus (may affect functionality, possibility water is leaking into panel)

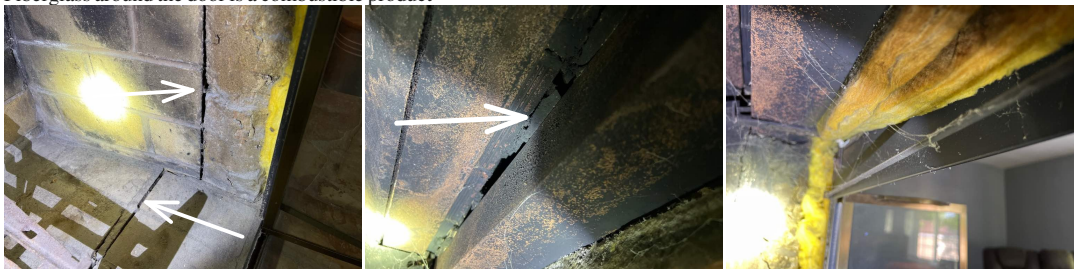
☐☐☐☒☐ **Flue:** Clay Tile Liner >>> Dry stacked or appearance of (there is or may be no mortar in the joints between the clay liners as required)
☒☐☐☐☐ **Smoke Chamber:** Brick
☒☐☐☐☐ **Damper:** Metal (Above Firebox)
☐☐☐☒☐ **Firebox:** Brick Construction >>> Mortar missing from joints between bricks compromising fire box
Voids in pointing at the joint to brick (in front above opening)
Fiberglass around the door is a combustible product

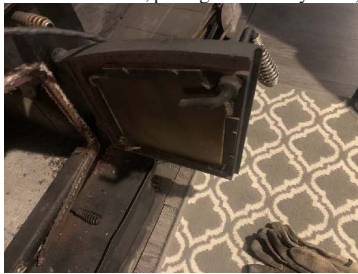
☒☐☐☐☐ **Stove:** Wood Burning
☒☐☐☐☐ **Flue:** Single Wall Pipe to Chimney
☒☐☐☐☐ **Damper:** In Stove
☒☐☐☐☐ **Blower:** Operates
☒☐☐☐☐ **Mantle Secure:** Appears To Be
☒☐☐☐☐ **Surround:** Brick
☐☐☐☒☐ **Hearth:** Non Combustible Materiel >>> Less than the minimum required depth of non combustible surface (18 inches for older installations / 20 volt niches for new installations, posing a fire safety issue)

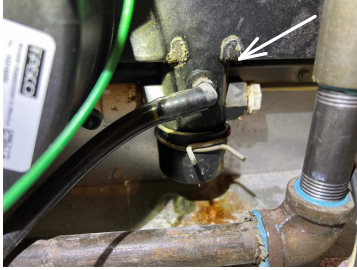
☐☐☐☒ **Flue Pipe:** PVC Pipe >>> Condensate active leak to right of inducer motor

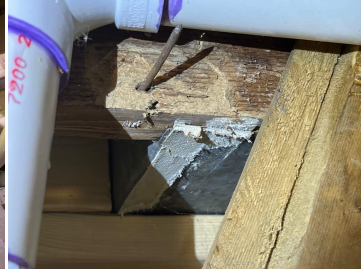
☐☐☐☒ **Potential Asbestos:** Appearance Of >>> Tape on ducts in basement storage room (potential health issue, requires specialist evaluation to determine a course of action)(FAQ/Asbestos)

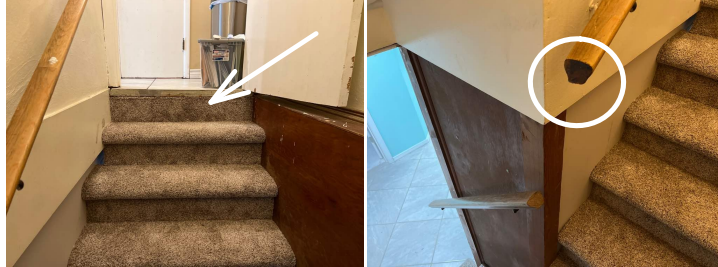
Basement Stairs: Wood Construction >>> Step height riser exceeds 7.75 inch maximum height (posing a potential trip hazard)
Handrail end's do not return against wall

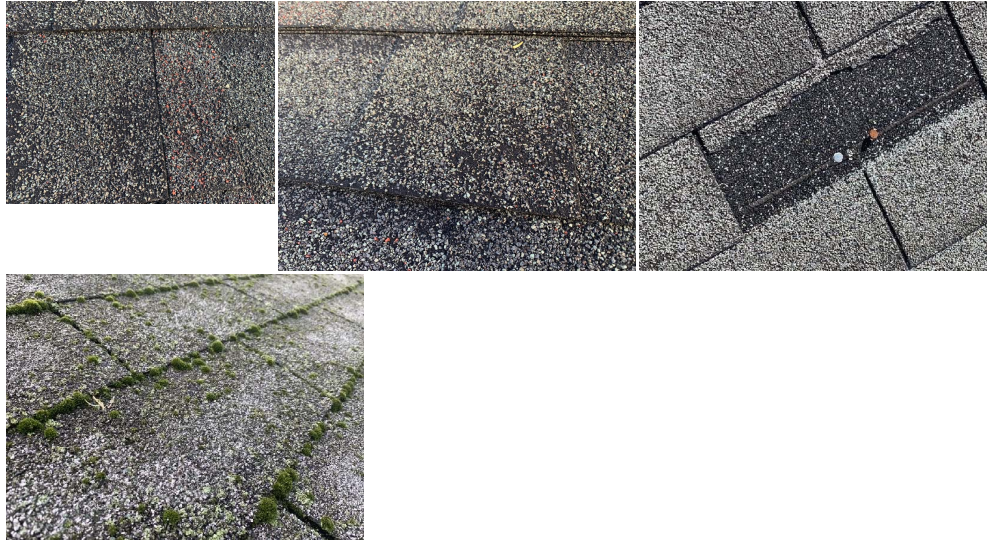
Moss/ algae on surface (detrimental to surface)
