Property Inspection Report

404 Inspection Way
Dayton, OH 45499

GENERAL INFORMATION

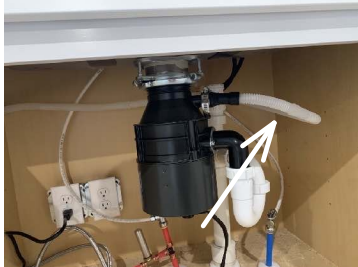
- ☐☐☐☒ **Dishwasher:** General Electric (Brand) >>> Drain pipe does not loop up as required (top of loop must be against underneath of countertop, called a high loop which prevents siphoning, some newer units may have the high loop built into the machine - check owners manual)

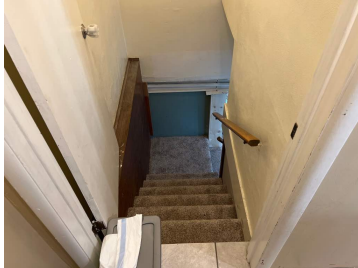
- ☒☐☐☐☐ **Pantry:** (Walk In)
☒☐☐☐☐ **Ceiling:** Textured Finish
☐☐☐☐☐ **Walls:** Painted Surface
☒☐☐☐☐ **Floor:** Vinyl Covered
☐☐☒☐☐ **Doors:** Hollow Core >>> Opens out over stair or step down (not permitted, potential trip hazard, safety concern)

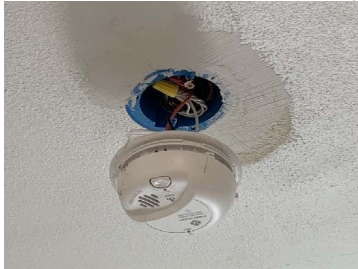
- ☒☐☐☐☐ **Ceiling:** Soft Textured Finish
- ☒☐☐☐☐ **Walls:** Painted Surface
- ☒☐☐☐☐ **Floor:** Laminate Covered >>> NOTE: Not level and appears not to affect structural integrity (recommend monitoring, may need repair in future)
- ☒☐☐☐☐ **Electric:** Lighting Circuit (No receptacles)
- ☐☐☐☒☐ **Smoke/ Fire Alarm:** Permanent Unit (linked to other units) >>> Hanging by wire (did not inspect mounting bracket for damage)

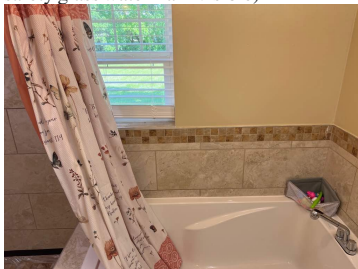
- ☐☐☐☒ **Bath:** Acrylic/Fiberglass Tub >>> Not draining as expected (slow, reason undetermined)
- ☒☐☐☐☐ **Bath Surround:** Tile
- ☒☐☐☐☐ **Ventilation:** Electric Exhaust Fan
- ☒☐☐☐☐ **Ceiling:** Smooth Finish
- ☒☐☐☐☐ **Walls:** Painted Surface
- ☒☐☐☐☐ **Floor:** Ceramic Tile
- ☒☐☐☐☐ **Doors:** Hollow Core
- ☐☐☐☒ **Windows:** Vinyl Sash/Frame >>> Safety glass not installed (required for windows less than 5' above bath tub in structures built or remodeled after 1977, no safety glass watermark visible)

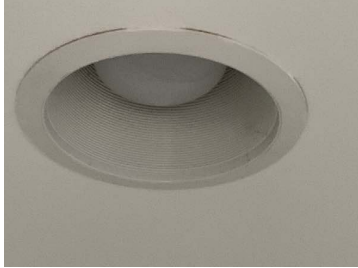
☐☐☐☒ **Electric:** Lighting & Receptacle Circuits >>> Light fixture with exposed bulb not designed or permitted for installation above moist areas (do not use affected shower/tub until replaced, safety issue)

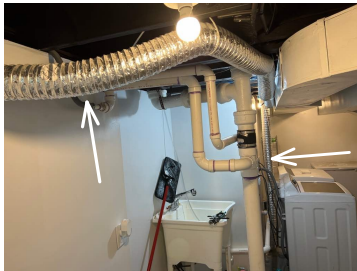
- ☒ ☐ ☐ ☐ ☐ **Washer & Dryer Electrical:** Washer 110 volt & Dryer 220 volt Receptacles
- ☒ ☐ ☐ ☐ ☐ **Washer Hose Connection:** Wall Box (with Hot & Cold Valves)
- ☒ ☐ ☐ ☐ ☐ **Washer Drain:** Wall Box (with Drain)
- ☐ ☐ ☐ ☒ **Dryer Vent Pipe:** Rigid Metal, Foil Flex (recommend upgrading) >>> Too long for dryer to operate properly exceeding the thirty five equivalent feet maximum allowed length, presently @ 37 Eq Ft. (measure straight pipe from point flex connector attaches and add 5' for each elbow, combined total must be 35' or less, due to excessive length it will be prone to blockages and poor dryer performance) 25 EQ ft is the most many dryers can push lint through without problems (FAQ-Appliances)

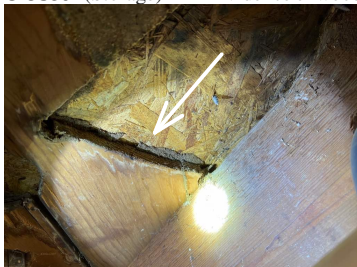
- ☐ ☐ ☐ ☒ **Closet:** (Storage) >>> Evidence of wood destroying insect infestation under shower base

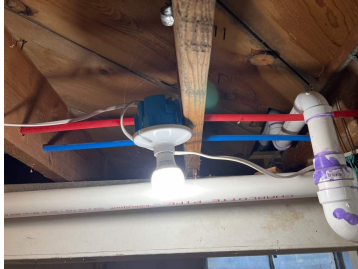
☐☐☐☒ **Electrical:** Components >>> Wiring not secured to structure within 18 inches of junction box as required

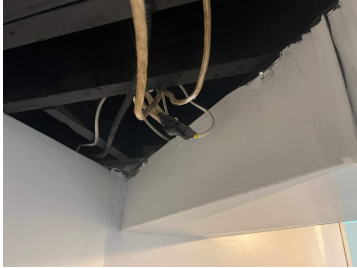
☐☐☐☒ **Electrical:** Components >>> Wire splice is not in a junction box (exposed live connections pose a safety issue)

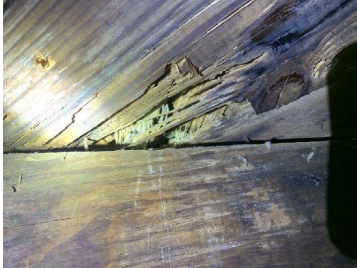
☒☐☐☐☐ **Access:** From Basement
☐☒☐☐☐ **Unable to Inspect:** Behind Insulation
☒☐☐☐☐ **Evidence of Moisture:** No (Dry)
☒☐☐☐☐ **Sill Plate/ Band Board:** Dimensional Lumber
☐☐☐☒ **Sub Floor:** Dimensional Lumber >>> Evidence of wood destroying infestation with damage that may be worse than what is visible (FAQ/Termite)

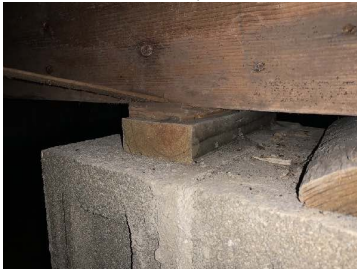
☒☐☐☐☐ **Joists:** Lumber (Dimensional)
☒☐☐☐☐ **Insulation:** Rigid Polystyrene
☒☐☐☐☐ **Ventilation:** Static Vents
☒☐☐☐☐ **Foundation:** Concrete Block Construction
☐☐☐☒ **Beams:** Solid Wood >>> Shims between beam and load bearing member(s) are not adequate in size to support and spread weight effectively (beam may deform around shims and settle)

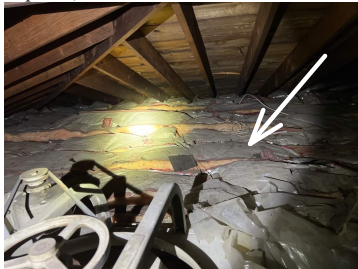
- ☒☐☐☐ **Insulation Depth:** 6 Inches Approx
- ☐☐☐☒ **Insulation Vapor Barrier:** Foil over Kraft Paper (Radiant heat barrier) >>> Installed incorrectly (vapor barrier not on the heated side of the insulation as required)

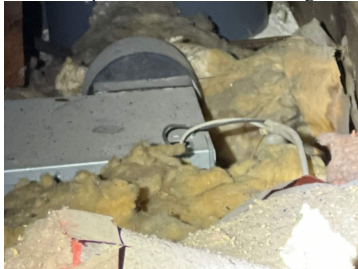
- ☒☐☐☐ **Animals/ Pests:** No Evidence Visible
- ☐☐☒☐ **Electrical:** Components >>> Wiring loose/ not secured to structure as required (must be stapled tight, max 4'6 inches between fasteners and within 18 inches of junction box)
- ☐☐☒☐ **Bathroom Fan Venting:** Vents into Attic Area >>> Not vented to the exterior (venting moist air into structure may affect components, potential for mold)
Wire clamp not used on wire entering fan housing

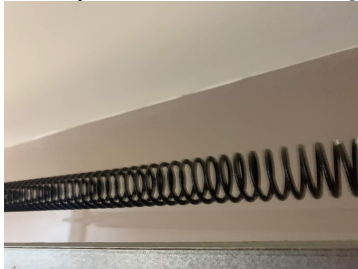
☐ ☐ ☐ ☒ ☐ **Door Operation:** Mechanized (Uses opener) >>> Safety wire not installed (goes through springs prevents injury if springs break, requirement)

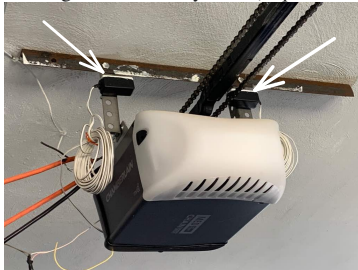
☐ ☐ ☐ ☒ ☐ **Door Opener:** Chamberlain (Brand) >>> Motion sensor safety bypassed or located in area other than at bottom of the door frame rendering it inoperative and a creating a serious safety issue (requirement is that sensor must be installed 4 to 6 inches from the floor depending on brand)

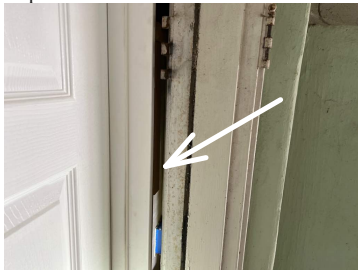
☐ ☐ ☐ ☒ ☐ **House Door:** Hollow Wood (Uninsulated) >>> Not insulated or solid type (does not meet fire separation rule for garage/ house access)
Self closing mechanism inoperative or not installed as required (fire & CO safety issue)
Gap around door breaches fire wall

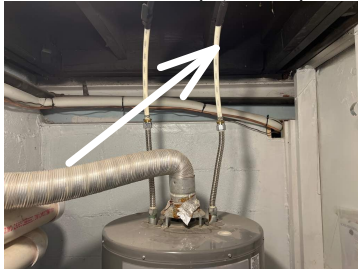
Water Lines: Pex Pipe (Flexible plastic type) >>> No shut off valve at supply to water heater (requirement)

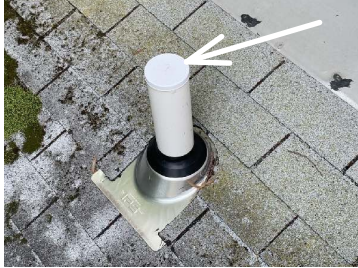
☐☐☐☒ **Plumbing Soil Vent:** Cast Iron Pipe, PVC Pipe >>> Capped off on roof (since time of construction, will cause drainage problems until opened)

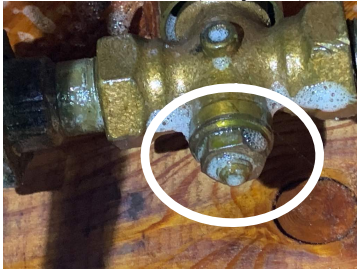
- ☒☐☐☐☐ **Inaccessible Appliance Connector:** No
☐☒☐☐☐ **Inaccessible Piping In Walls:** Yes (Not Inspected)
☒☐☐☐☐ **All Piping Accessible:** Yes (within the habitable area)
☐☐☐☒ **Leaks Found:** YES (safety issue) >>> Leaking at pipe to pilot

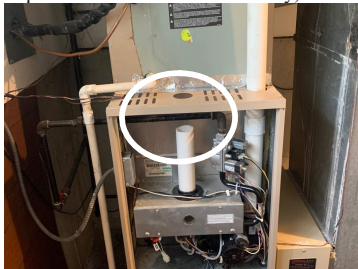
☐☐☐☒☐ **Operation:** Unit Responds to Controls >>> Unfinished installation of high efficiency furnace (combustion air intake pipe does not use air from exterior as required to achieve rated efficiency)

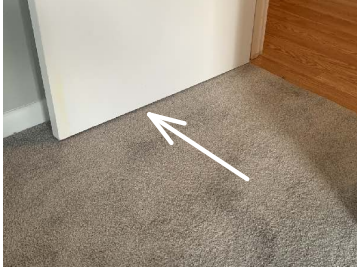
☐☐☒☐☐ **Air Return:** Located on the first floor >>> Door length restricts return air flow particularly in bedrooms that do not have return vents (minimum 1 inch gap required at floor to prevent room overheating, comfort issue)

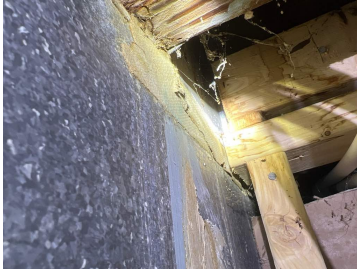
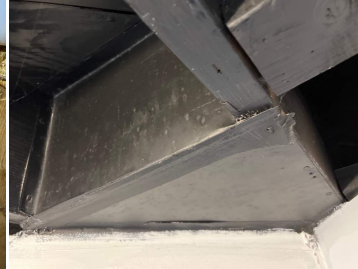
☐☐☐☒ **Potential Asbestos:** Appearance Of >>> Tape on ducts in basement storage room (potential health issue, requires specialist evaluation to determine a course of action)(FAQ/Asbestos)

Comment: The asbestos comment in the report is for guidance only, no testing or analysis has been performed to determine that the material identified is in fact asbestos. Client is recommended to consider the product as asbestos until such time as they have it tested and determined otherwise.

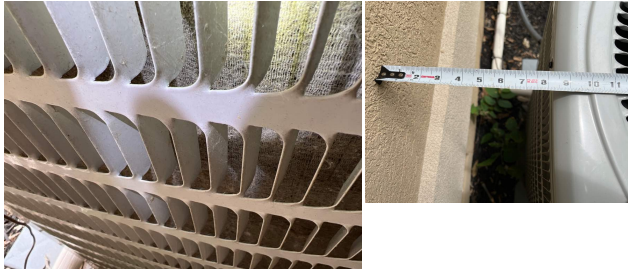
☒ ☐ ☐ ☐ ☐ **Operation:** Unit Responds to Controls
☒ ☐ ☐ ☐ ☐ **Temperature Differential:** 15/16 degrees (Delta-T)(Temp difference between flow and return vents)
☒ ☐ ☐ ☐ ☐ **Evaporator Coil:** (Interior Component)
☒ ☐ ☐ ☐ ☐ **Condensate Removal:** Pump with Pipe to Drain
☐ ☐ ☐ ☒ ☐ **Condensing Unit:** Pad Mounted (Exterior Unit) >>> Coil fins dirty (reduces air flow and affects efficiency of the cooling system)
Clearance to wall is less than the standard 10 inches requirement (reduces airflow through the unit, affecting overall efficiency of the system, recommend checking installation instructions for a variance)

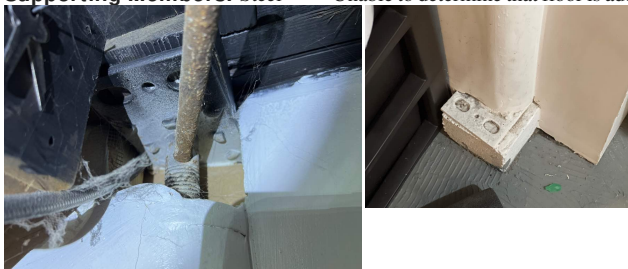
☒ ☐ ☐ ☐ ☐ **Foundation:** Poured Concrete Construction
☒ ☐ ☐ ☐ ☐ **Beams:** Steel I-Beam >>> NOTE: Not fully visible
☐ ☐ ☐ ☒ ☐ **Supporting Members:** Steel >>> Unable to determine that floor is adequate foundation for added load bearing pier (normally requires a foundation pad)

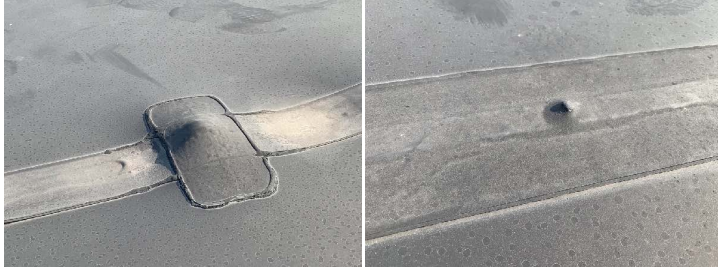
☐☐☐☒ **Material:** Rubber Membrane (EPDM) >>> Fasteners pushing up (potential for damage and moisture intrusion)

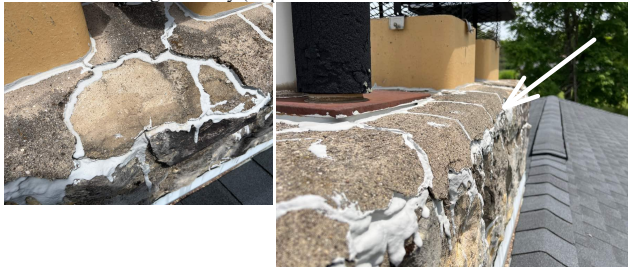
☐☐☐☒ **Crown/ Cap:** Concrete >>> Deteriorating surface

Does not overhang chimney (required to throw off rain water)

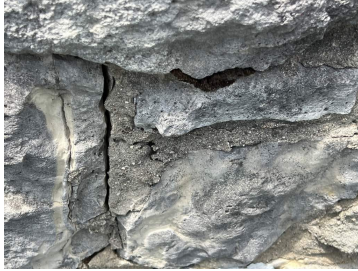
- ☐☐☐☒ **Construction:** Stone >>> Cracks in exterior (recommend having liner inspected)
Stone deterioration starting

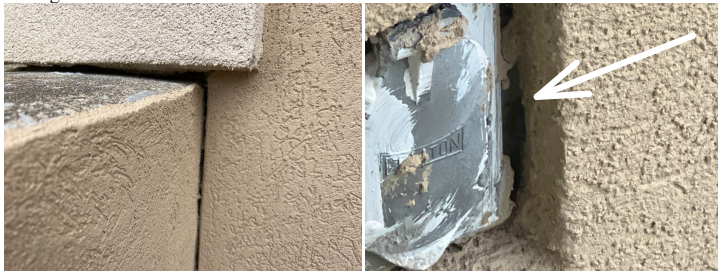
- ☐☐☐☒ **Surface:** Exterior Insulated Finishing System (EIFS Stucco) (FAQ-Exterior) >>> Numerous unsealed joints in surface with potential for water intrusion and damage to substrate

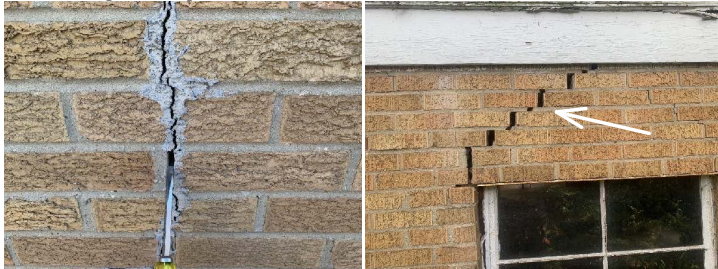
- ☐☐☐☒ **Surface:** Brick(FAQ-Exterior) >>> Cracks with 1/4 inch movement or settling on right gable (appears may be foundation related, need to determine cause and repair as required)

Cracks above rear window with movement or settling that appears to be foundation related (recommend evaluation by foundation or structural specialist to determine cause and repair as required)

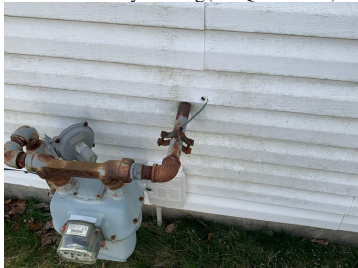
- ☐☐☒☐☐ **Surface:** Vinyl Siding(FAQ-Exterior) >>> Utility/ service equipment penetrating exterior are not sealed (water intrusion possible at pipes, wires, fittings)

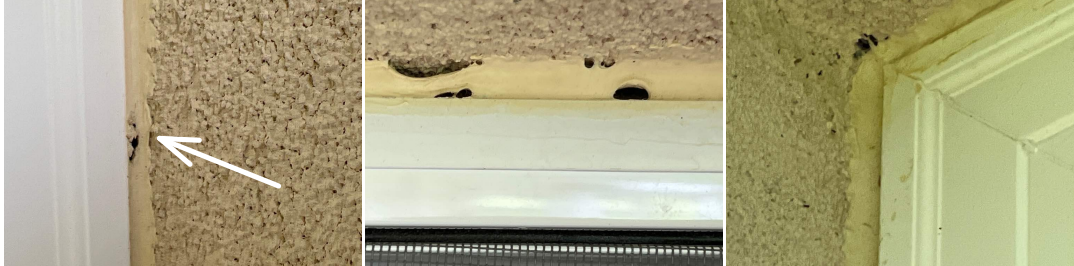
☐☐☐☒ **Caulking:** Sealant >>> Joints failing or not fully sealed at numerous windows (Potential for water intrusion)

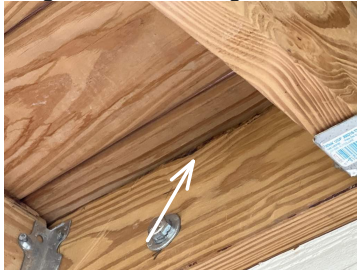
☐☐☐☒ **Ledger Board Flashing:** None >>> Flashing not installed at structure wall (may cause ledger board and or buildings band boards to rot prematurely)

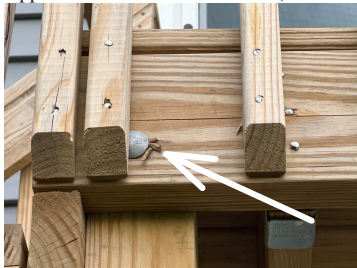
☐☐☐☒ **Beams:** Dimensional Lumber >>> Beams are fastened to the supporting posts inadequately using only one bolt at each joint in place of two as required (safety issue)

Appear to be undersized for load (deck failure possible, safety concern)

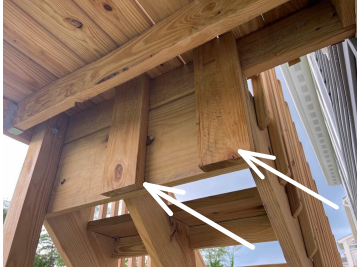
☐☐☐☒ **Steps:** Dimensional Lumber >>> Drop header is inadequate support or bracing for stair (poses a safety issue)

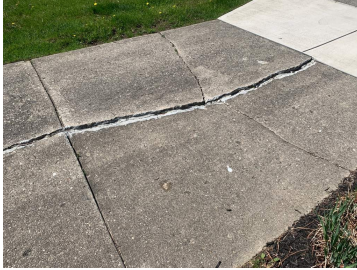
☐☐☐☒ **Driveway:** Concrete Surface(FAQ-Sealants) >>> Cracks in surface with settling and deterioration (budget for future repair)

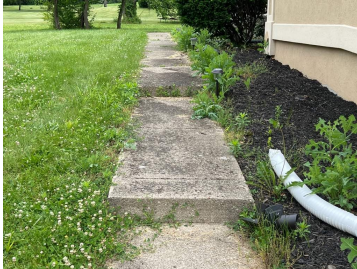
☐☐☒☐ **Walkways:** Concrete(FAQ-Sealants) >>> Settled section n front

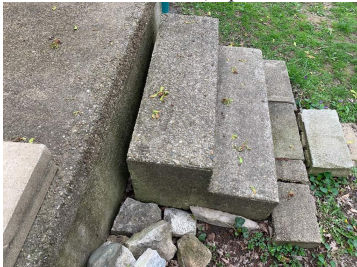
☐☐☐☒ **Rear Steps:** Concrete(FAQ-Sealants) >>> Bottom step is makeshift posing a safety issue
Hand rails not installed (required with four or more risers)

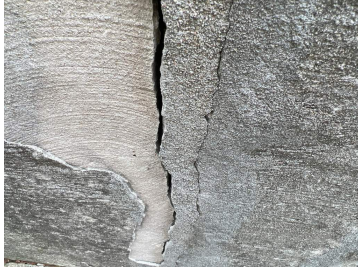
☐☐☒☐ **Retaining Walls:** Stone >>> Has active movement 1 inch crack visible

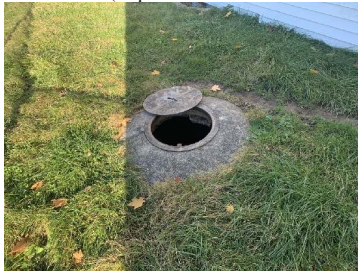
☐☐☒☐ **Cistern (Underground Water Tank):** Rear Yard >>> Abandoned (not in use),
Not filled in (requirement for unused cisterns is that they are filled in with gravel or sand, safety issue)

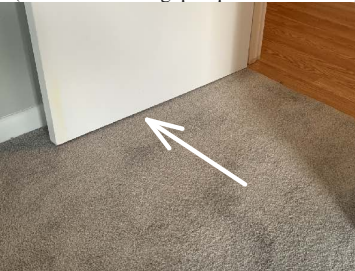
5. **(In Bathroom) Furnace Air Return:** Located on the first floor >>> Door length restricts return air flow particularly in bedrooms that do not have return vents (minimum 1 inch gap required at floor to prevent room overheating, comfort issue)

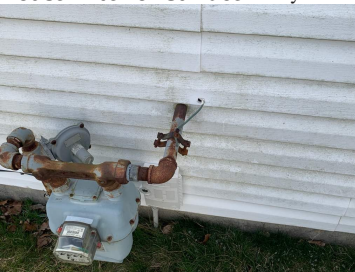
7. **House Exterior Surface:** Vinyl Siding(FAQ-Exterior) >>> Utility/ service equipment penetrating exterior are not sealed (water intrusion possible at pipes, wires, fittings)

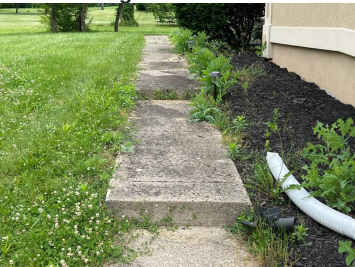
8. **Surrounding Area Grounds Walkways:** Concrete(FAQ-Sealants) >>> Settled section n front

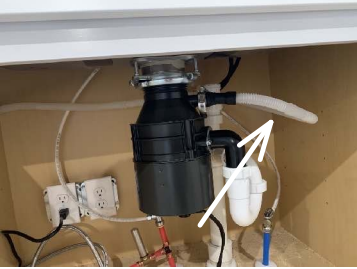
4. **The Kitchen Dishwasher:** General Electric (Brand) >>> Drain pipe does not loop up as required (top of loop must be against underneath of countertop, called a high loop which prevents siphoning, some newer units may have the high loop built into the machine - check owners manual)

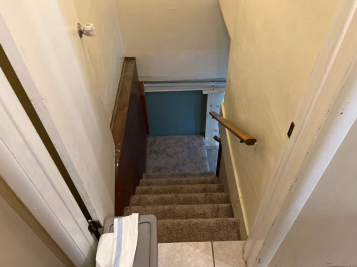
5. **The Kitchen Counter Top:** Laminate (Surface) >>> Loose or not adequately secured to base (safety issue)
6. **The Kitchen Doors:** Hollow Core >>> Opens out over stair or step down (not permitted, potential trip hazard, safety concern)

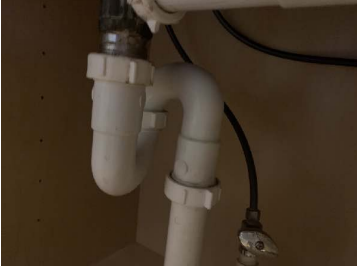
11. **Kitchen Area Half Bath Sink:** Single Bowl >>> Drain plug not operational
S-Trap on drain is not permitted (tendency for sewer gasses to escape, posing a health hazard)

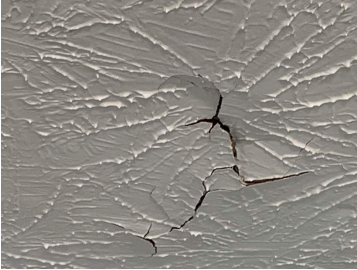
13. **Primary Bedroom Electric:** Lighting & Receptacle Circuits >>> Open ground (possibly a two prong ungrounded receptacle incorrectly replaced with a three prong grounded type without the necessary wiring, safety concern)
NOTE: Some receptacles not accessible to inspect
14. **Rear Center Bedroom Closet:** (Single Door) >>> Light fixture not operational (detected possible voltage, bulb blown?)
15. **Rear Center Bedroom Ceiling:** Textured Finish >>> Damaged area

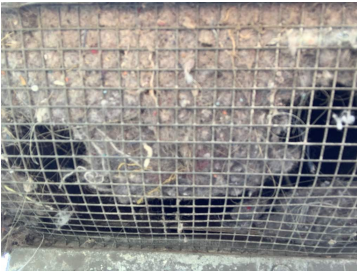
16. **Basement Laundry Dryer Vent Termination:** On Roof >>> Screen blocking air flow and lint (bird screen must be removed for dryer use, pipe may require cleaning, fire hazard)

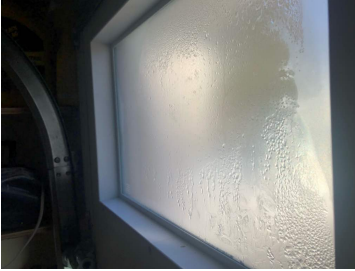
19. **Family Room in Finished/ Windows:** Vinyl Sash/Frame, Skylight (in ceiling) >>> Glass seal failed in sash x1 (moisture and/or fogging between glass in thermo pane unit)

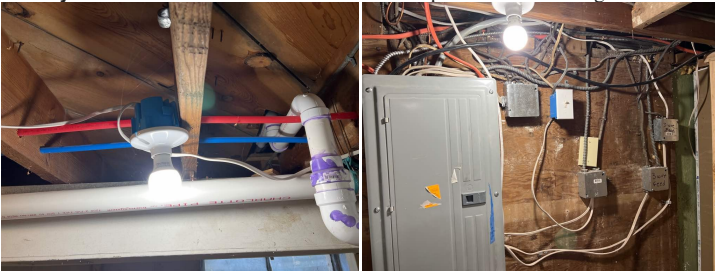
20. **Family Room in Finished/ Electric:** Lighting & Receptacle Circuits >>> Receptacle cover plate missing in storage room(exposing live connections)
21. **Family Room in Finished/ Electrical:** Components >>> Wiring not secured to structure within 18 inches of junction box as required

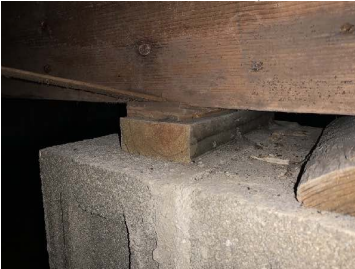
23. **The Crawl Beams:** Solid Wood >>> Shims between beam and load bearing member(s) are not adequate in size to support and spread weight effectively (beam may deform around shims and settle)

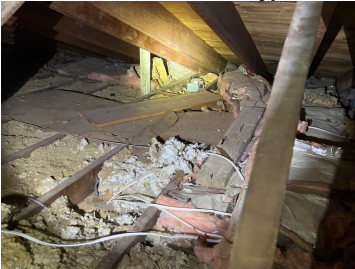
24. **House Attic Attic Access:** Ceiling Panel >>> Not insulated (allowing unwanted heat transfer, reducing the overall insulation value)
25. **House Attic Insulation Type:** Batting(FAQ-Attic), Cellulose Loose Fill(FAQ-Attic) >>> Pulled back from area(s) (allowing unwanted heat transfer from below)

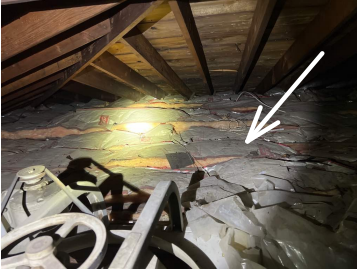
26. **House Attic Insulation Vapor Barrier:** Foil over Kraft Paper (Radiant heat barrier) >>> Installed incorrectly (vapor barrier not on the heated side of the insulation as required)

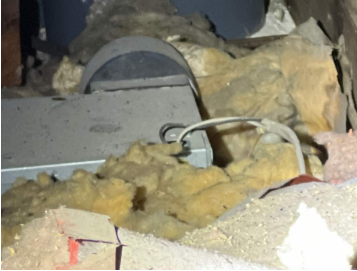
27. **House Attic Electrical: Components** >>> Wiring loose/ not secured to structure as required (must be stapled tight, max 4'6 inches between fasteners and within 18 inches of junction box)
28. **House Attic Bathroom Fan Venting: Vents into Attic Area** >>> Not vented to the exterior (venting moist air into structure may affect components, potential for mold)
Wire clamp not used on wire entering fan housing

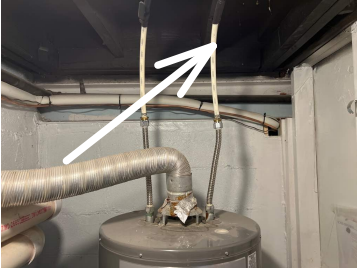
32. **Water Lines: Pex Pipe(Flexible plastic type)** >>> No shut off valve at supply to water heater (requirement)

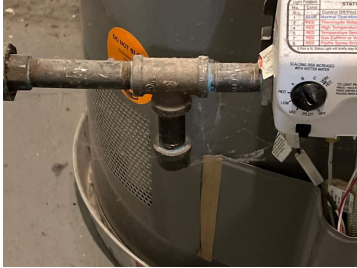
33. **Basement: Water Heater Gas Lines:** Black Iron Pipe >>> Dirt leg/ Sediment trap incorrectly installed (pipe straight through, cannot perform intended function)

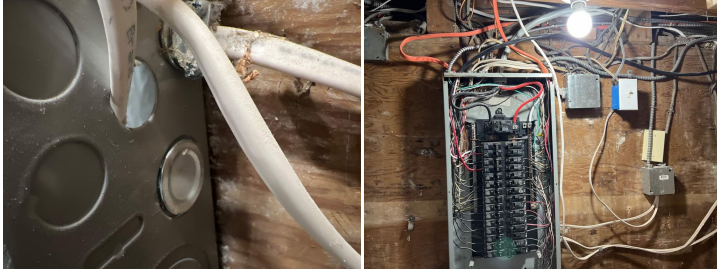
34. **(Basement) Electric Panel Panel Box:** Seimens (Manufacturer) >>> Wire(s) entering panel box are not clamped (required)
Wiring not secured to structure within 18 inches of panel as required
Insulated covered wires (inside box, wires insulation must be stripped back to entry point)

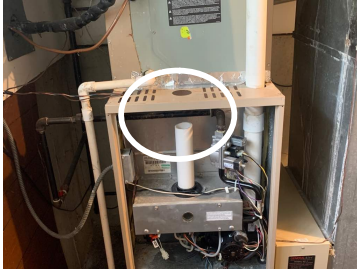
35. **(In Bathroom) Furnace Operation:** Unit Responds to Controls >>> Unfinished installation of high efficiency furnace (combustion air intake pipe does not use air from exterior as required to achieve rated efficiency)

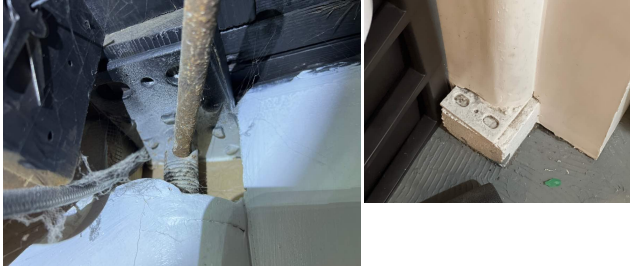
37. **Supporting Members: Steel** >>> Unable to determine that floor is adequate foundation for added load bearing pier (normally requires a foundation pad)

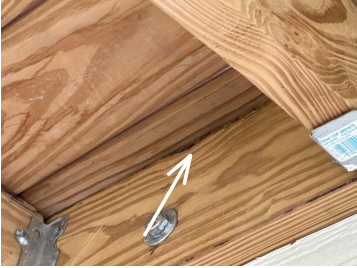
39. **Rear Deck Ledger Board Flashing:** None >>> Flashing not installed at structure wall (may cause ledger board and or buildings band boards to rot prematurely)

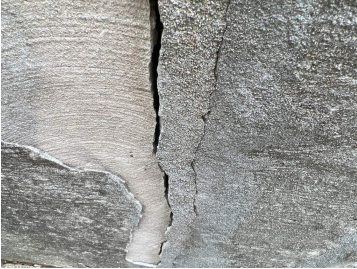
40. **Surrounding Area Grounds Retaining Walls:** Stone >>> Has active movement 1 inch crack visible

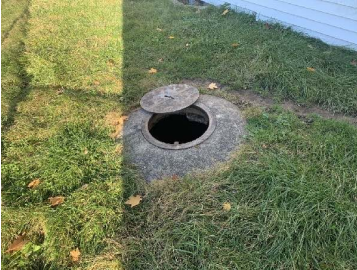
41. **Surrounding Area Grounds Cistern (Underground Water Tank):** Rear Yard >>> Abandoned (not in use), Not filled in (requirement for unused cisterns is that they are filled in with gravel or sand, safety issue)

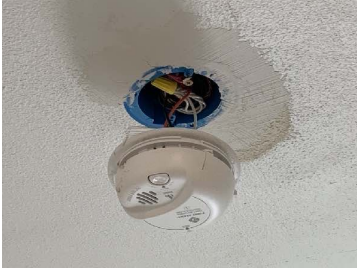
1. **Hallway/ Interior Smoke/ Fire Alarm:** Permanent Unit (linked to other units) >>> Hanging by wire (did not inspect mounting bracket for damage)

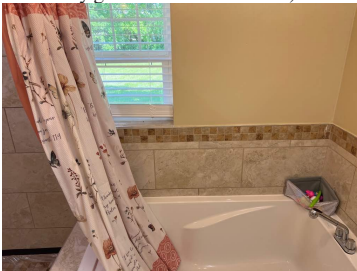
6. **Hall Bathroom Windows:** Vinyl Sash/Frame >>> Safety glass not installed (required for windows less than 5' above bath tub in structures built or remodeled after 1977, no safety glass watermark visible)

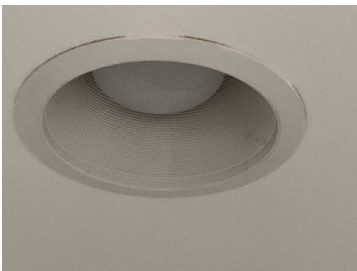
7. **Hall Bathroom Electric:** Lighting & Receptacle Circuits >>> Light fixture with exposed bulb not designed or permitted for installation above moist areas (do not use affected shower/tub until replaced, safety issue)

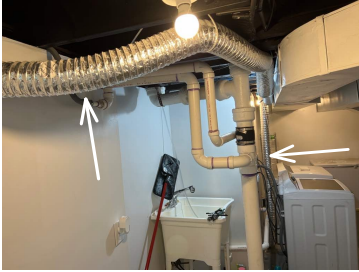
9. **Basement Laundry Dryer Vent Pipe:** Rigid Metal, Foil Flex (recommend upgrading) >>> Too long for dryer to operate properly exceeding the thirty five equivalent feet maximum allowed length, presently @ 37 Eq Ft. (measure straight pipe from point flex connector attaches and add 5' for each elbow, combined total must be 35' or less, due to excessive length it will be prone to blockages and poor dryer performance) 25 EQ ft is the most many dryers can push lint through without problems (FAQ-Appliances)

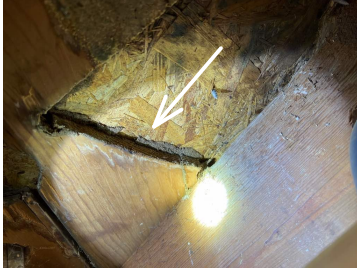
10. **Family Room in Finished/ Closet:** (Storage) >>> Evidence of wood destroying insect infestation under shower base

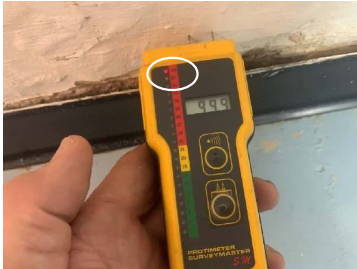
11. **Family Room in Finished/ Walls:** Painted Surface >>> Staining with possible appearance of biological activity (damp, potential health issue, recommend testing for mold to determine a course of action and repair, potential Health Issue)

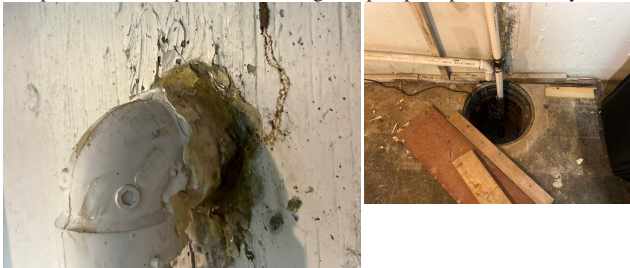
12. **Family Room in Finished/ Sump:** with Submerged Pump >>> Cover missing from sump (safety issue)
 Discharge pipe leaking in structure (may cause damage and mold)
 Pump float switch is positioned too high for pump to operate correctly

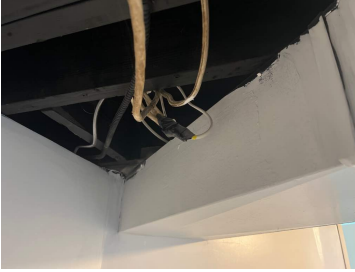
13. **Utility Room in Finished/ Electrical:** Components >>> Wire splice is not in a junction box (exposed live connections pose a safety issue)

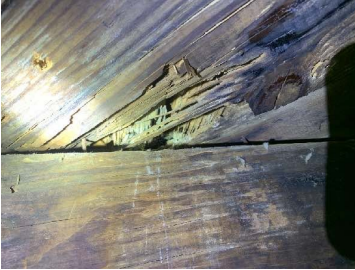
14. **The Crawl Sub Floor:** Dimensional Lumber >>> Evidence of wood destroying infestation with damage that may be worse than what is visible (FAQ/Termite)

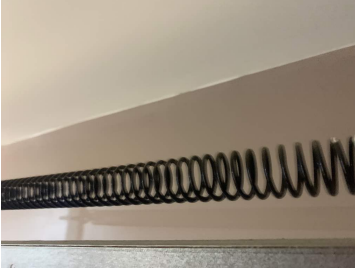
15. **Tuck Under Garage Door Operation:** Mechanized (Uses opener) >>> Safety wire not installed (goes through springs prevents injury if springs break, requirement)

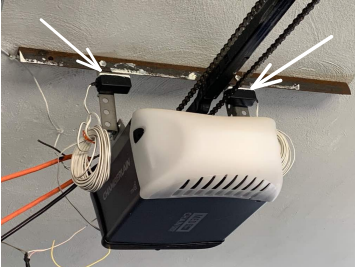
16. **Tuck Under Garage Door Opener:** Chamberlain (Brand) >>> Motion sensor safety bypassed or located in area other than at bottom of the door frame rendering it inoperative and a creating a serious safety issue (requirement is that sensor must be installed 4 to 6 inches from the floor depending on brand)

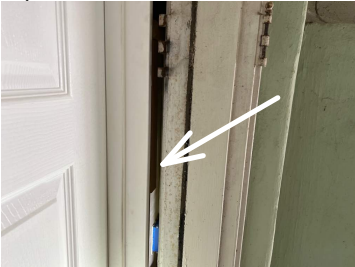
17. **Tuck Under Garage House Door:** Hollow Wood (Uninsulated) >>> Not insulated or solid type (does not meet fire separation rule for garage/ house access)
Self closing mechanism inoperative or not installed as required (fire & CO safety issue)
Gap around door breaches fire wall

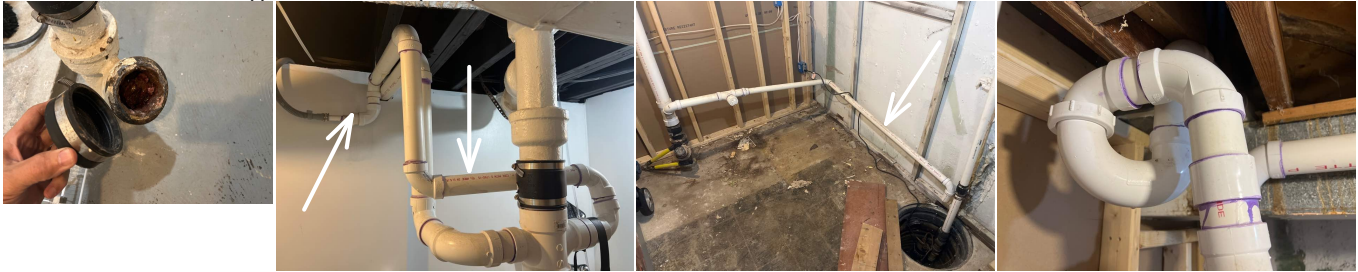
- 19. Drains:** Cast Iron Pipe, Galvanized Pipe, PVC Pipe >>> Clean-out not sealed or capped off on main stack in utility room (venting sewer gas, posing a health issue) trends for cap are not usable & has been blocked with a rag
Landry sink drain has two traps on pipe: incorrect
No trap and upward PVC sloping pipe on dishwasher connection in utility room
Unused drain at sump pump not sealed or capped off (venting sewer gas, posing a health issue)
Hall bathroom shower drain appears to be an S-trap: not permitted

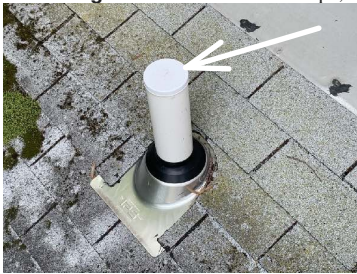
- 20. Plumbing Soil Vent:** Cast Iron Pipe, PVC Pipe >>> Capped off on roof (since time of construction, will cause drainage problems until opened)

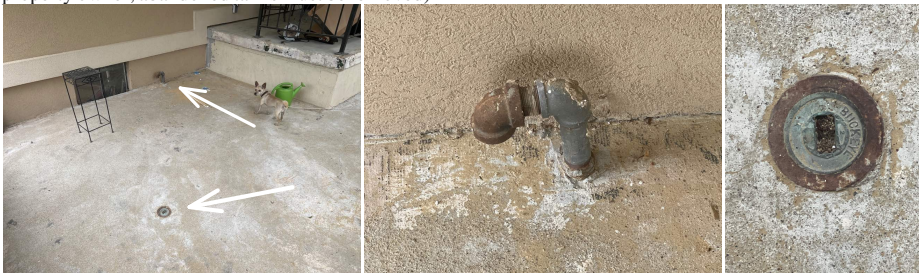
- 21. Fuel Tank:** Underground Abandoned >>> Vent or filler pipe visible outside indicating the possibility of an abandoned underground fuel oil tank (recommend checking with property owner, abandoned tanks must be removed)

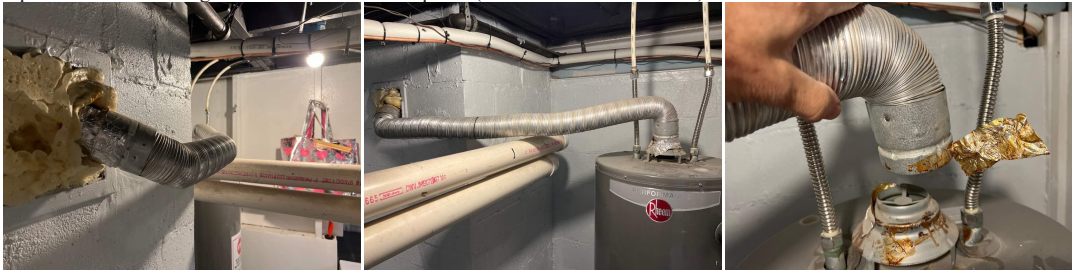
- 23. Basement: Water Heater Flue Pipe:** Flex Pipe to Chimney >>> Clearance between pipe and combustibles foam is inadequate (fire safety issue)
Negative downward sloped pipe (requirement is: a constant upward angle of not less than 1/4 inch per ft, carbon monoxide concern)
Pipe not secured to draught hood with screws as required (carbon monoxide concern)

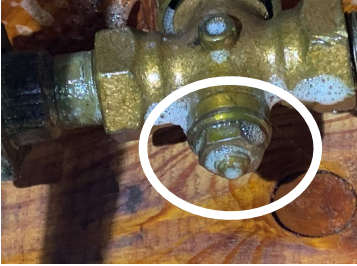
25. **Gas Leak Test Leaks Found:** YES (safety issue) >>> Leaking at pipe to pilot

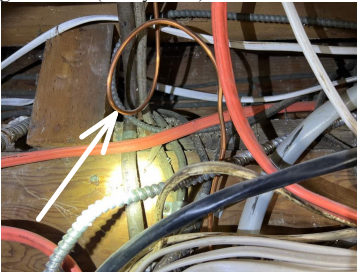
26. **Grounding/ Bonding:** Connected to the Plumbing >>> Plumbing ground not verified: wire is visible in garage
Ground wire from ground rod connected to sub panel : incorrect
No ground wire/ rod appears to have been installed from the new main exterior disconnect (new or updated electric distribution panel installations require grounding to copper ground rod (safety issue))

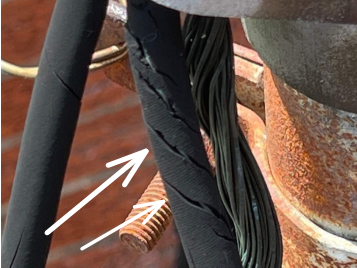
27. **Incoming Service:** Mast with Overhead Cable >>> Wires outer surface covering deteriorated on service entrance conductor (property owner responsibility)(FAQ-Electrical/ Service wire)
Splice at service point is not insulated (exposed live connections, generally responsibility of the utility company, electrocution possible, safety issue)

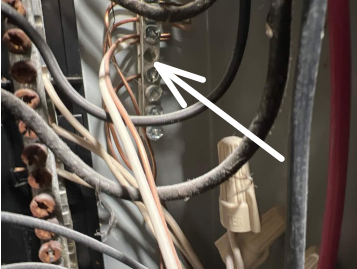
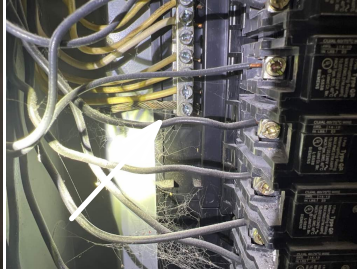
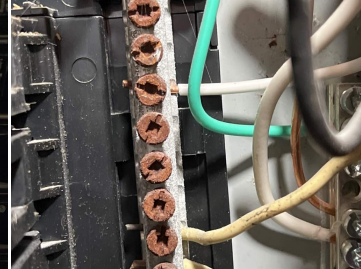
28. **(Basement) Electric Panel Neutral/ Ground Buss:** Separated/ Isolated >>> Neutral wire connected to isolated ground bus bar (error creating a cross connect)
Ground wires touching isolated neutral bus bar (creating a cross connection between separated neutral and ground wiring)
Corrosion or rust on neutral/ground bus (may affect functionality, possibility water is leaking into panel)

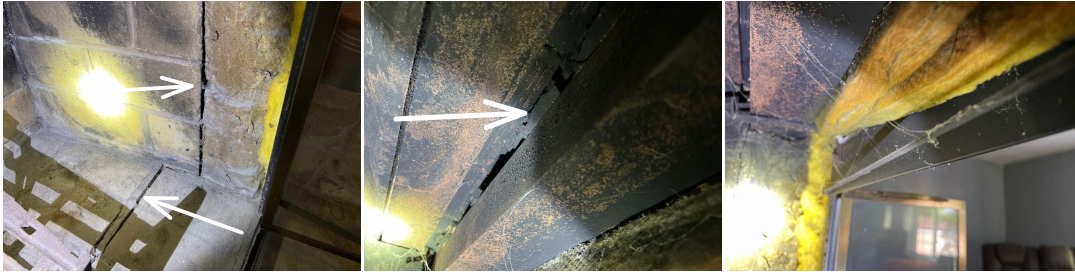
29. **Living Room Fireplace Flue:** Clay Tile Liner >>> Dry stacked or appearance of (there is or may be no mortar in the joints between the clay liners as required)
30. **Living Room Fireplace Firebox:** Brick Construction >>> Mortar missing from joints between bricks compromising fire box
Voids in pointing at the joint to brick (in front above opening)
Fiberglass around the door is a combustible product

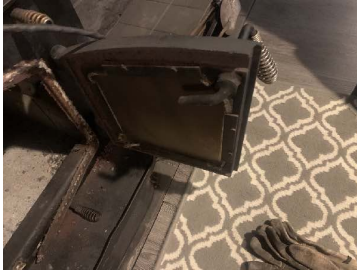
31. **Basement Freestanding Stove Hearth:** Non Combustible Material >>> Less than the minimum required depth of non combustible surface (18 inches for older installations / 20 inch niches for new installations, posing a fire safety issue)

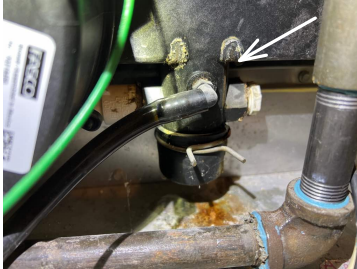
32. **(In Bathroom) Furnace Flue Pipe:** PVC Pipe >>> Condensate active leak to right of inducer motor

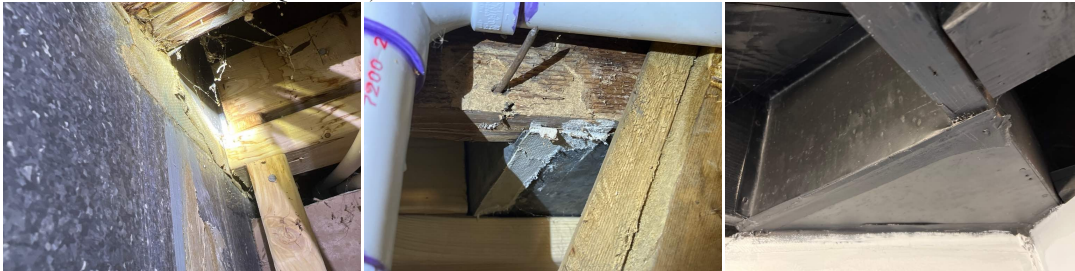
33. **(In Bathroom) Furnace Potential Asbestos:** Appearance Of >>> Tape on ducts in basement storage room (potential health issue, requires specialist evaluation to determine a course of action)(FAQ/Asbestos)

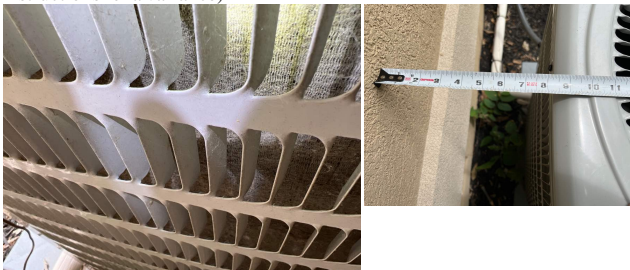
34. **Central A/C Condensing Unit:** Pad Mounted (Exterior Unit) >>> Coil fins dirty (reduces air flow and affects efficiency of the cooling system)
Clearance to wall is less than the standard 10 inches requirement (reduces airflow through the unit, affecting overall efficiency of the system, recommend checking installation instructions for a variance)

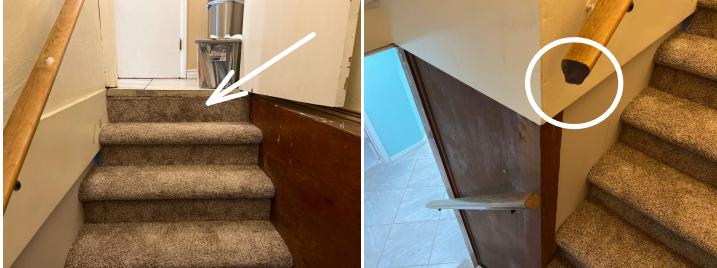
- 35. Basement Stairs:** Wood Construction >>> Step height riser exceeds 7.75 inch maximum height (posing a potential trip hazard)
Handrail end's do not return against wall

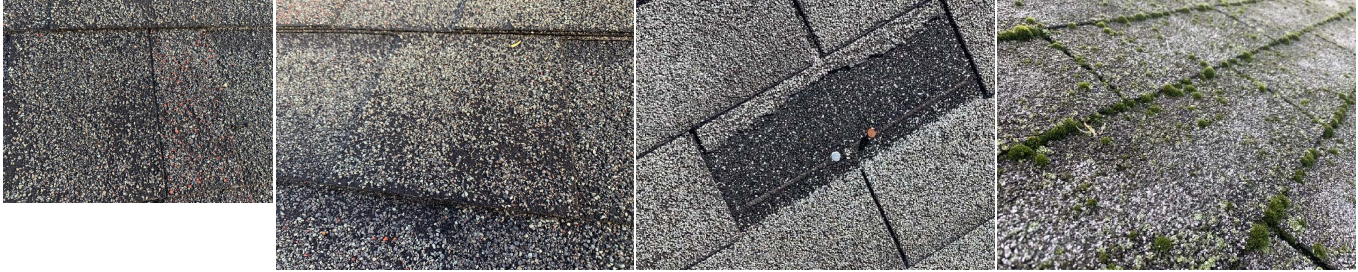
- 36. House Roof Material:** Three Tab Shingles >>> At end of functional life (due to surface deterioration, requires replacement) (FAQ-Roof)
Missing Tabs
Moss/algae on surface (detrimental to surface)

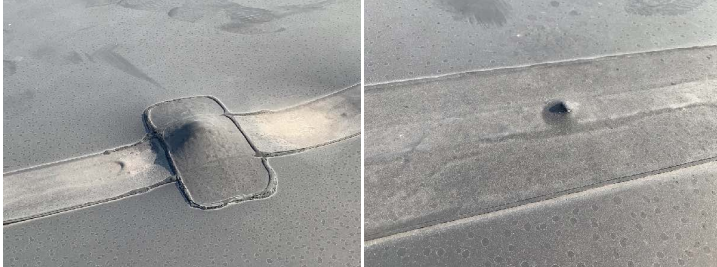
- 37. House Roof Material:** Rubber Membrane (EPDM) >>> Fasteners pushing up (potential for damage and moisture intrusion)

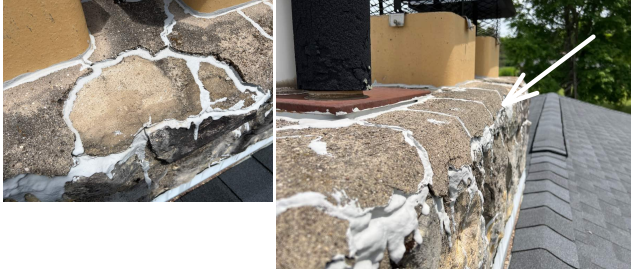
- 40. Center Chimney Crown/ Cap:** Concrete >>> Deteriorating surface
Does not overhang chimney (required to throw off rain water)

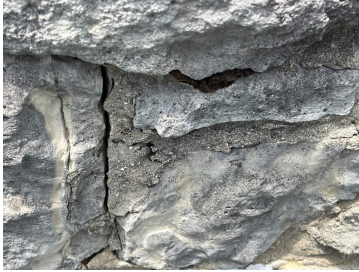
- 41. Center Chimney Construction: Stone** >>> Cracks in exterior (recommend having liner inspected)

Stone deterioration starting

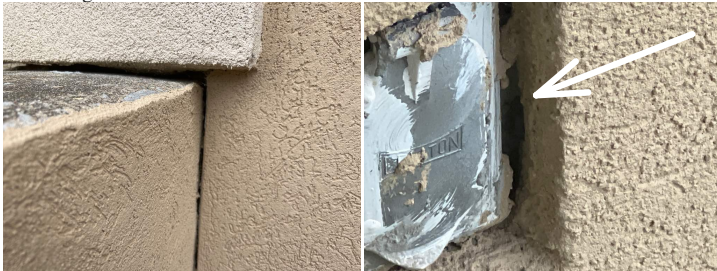
- 42. House Exterior Surface: Exterior Insulated Finishing System (EIFS Stucco)** (FAQ-Exterior) >>> Numerous unsealed joints in surface with potential for water intrusion and damage to substrate

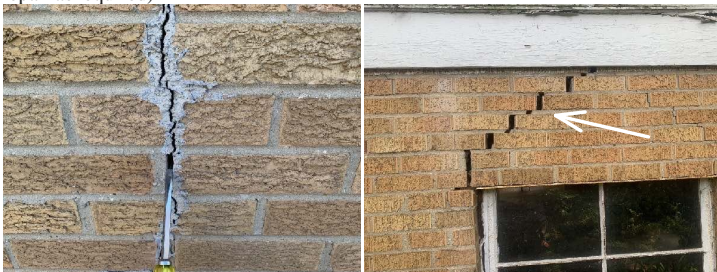
- 43. House Exterior Surface: Brick**(FAQ-Exterior) >>> Cracks with 1/4 inch movement or settling on right gable (appears may be foundation related, need to determine cause and repair as required)
Cracks above rear window with movement or settling that appears to be foundation related (recommend evaluation by foundation or structural specialist to determine cause and repair as required)

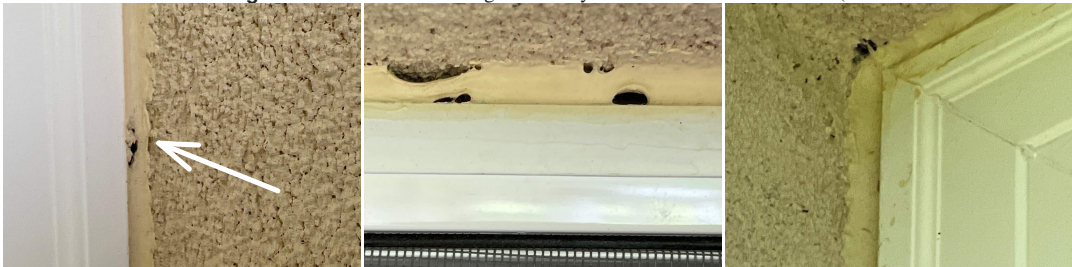
- 44. House Exterior Caulking: Sealant** >>> Joints failing or not fully sealed at numerous windows (Potential for water intrusion)

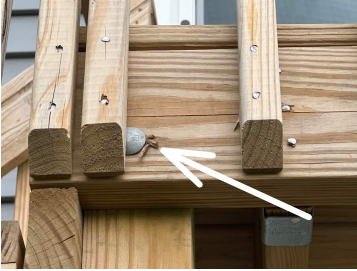
- 46. Rear Deck Beams:** Dimensional Lumber >>> Beams are fastened to the supporting posts inadequately using only one bolt at each joint in place of two as required (safety issue)
Appear to be undersized for load (deck failure possible, safety concern)

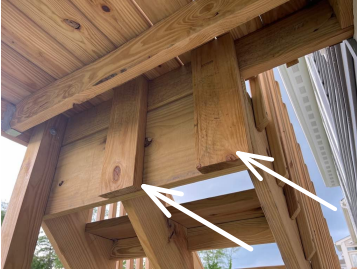
- 47. Rear Deck Steps:** Dimensional Lumber >>> Drop header is inadequate support or bracing for stair (poses a safety issue)

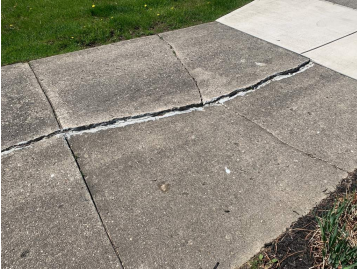
- 48. Surrounding Area Grounds Driveway:** Concrete Surface(FAQ-Sealants) >>> Cracks in surface with settling and deterioration (budget for future repair)

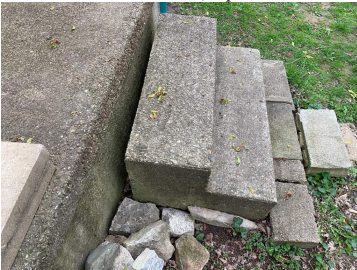
- 49. Surrounding Area Grounds Rear Steps:** Concrete(FAQ-Sealants) >>> Bottom step is makeshift posing a safety issue
Hand rails not installed (required with four or more risers)
